Accident Investigation Ship Design Report 2006-03

An investigation on stevedore safety on board a vessel, Friday, 08th December 2006, was leading to some weak points in maintenance.

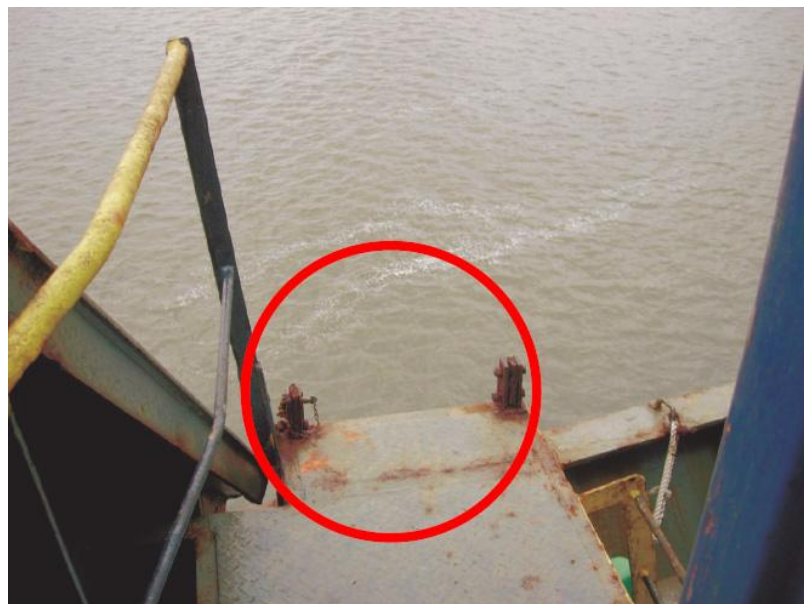
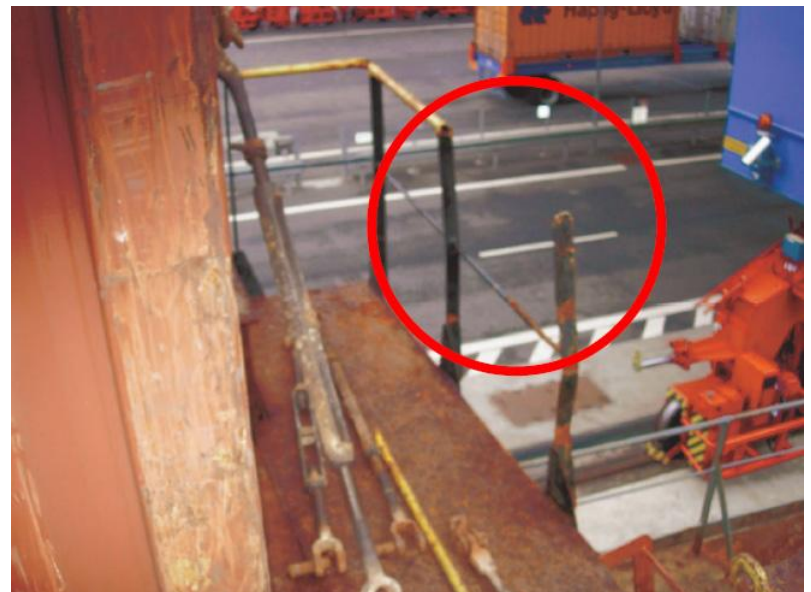
1. Missing and rotten fences.

On some working places on board the vessel, fences are missing or rotten.

All upper decks to which port workers may have access to carry out port work should be provided on the outer (inner) edges with guard rails that are so designed, constructed and placed, and of such a height above the deck, as to prevent any worker from accidentally falling.

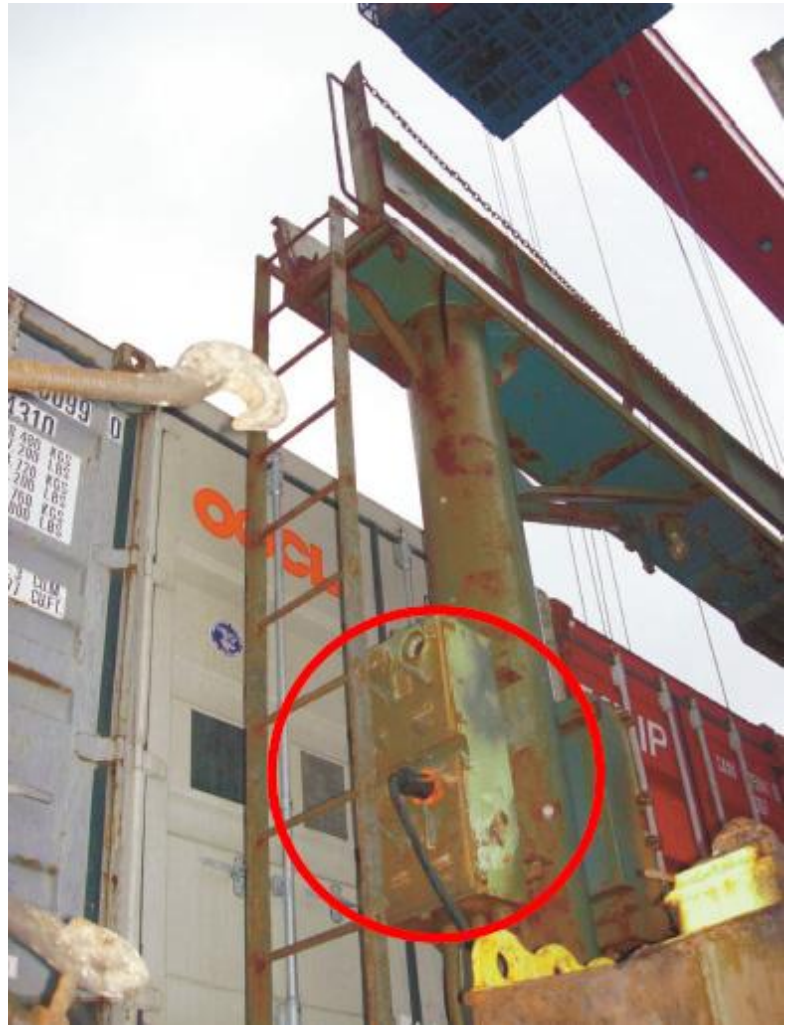
2. Rotten power plugs for Reefers.

All portable electrical equipment should be inspected at least daily by a competent person. Both had not taken place or the wrong actions were taken.

All electrical equipment should be examined and tested periodically by a competent person.
