Accident Investigation

Ship Design Report 2006-01

Monday, 06th November 2006

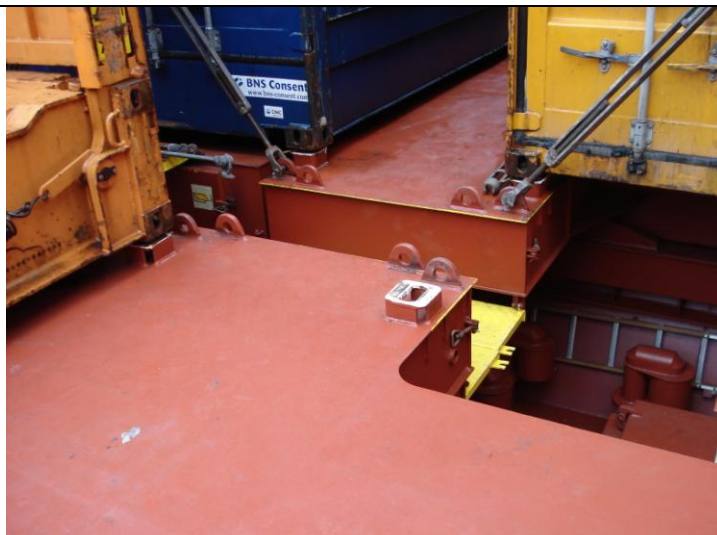
1. No fenced transit areas and working places.

All upper decks to which port workers may have access to carry out port work should be provided on the outer (inner) edges with guard rails that are so designed, constructed and placed, and of such a height above the deck, as to prevent any worker from accidentally falling.

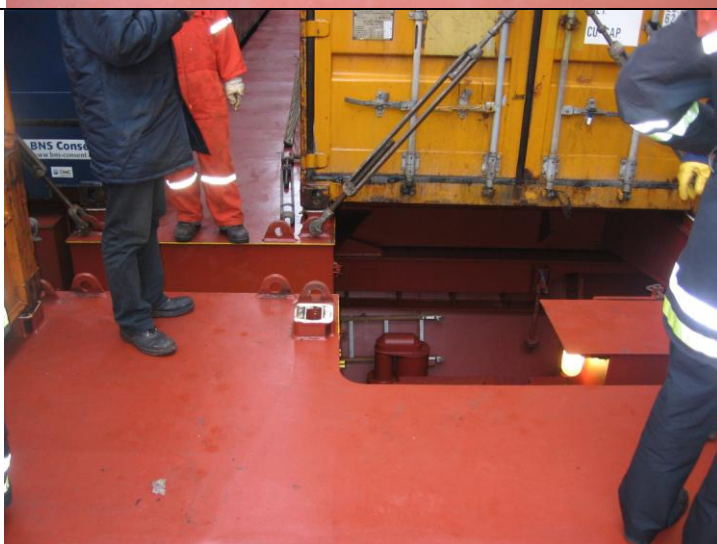
2. Lashing eyes are obstacles in transit areas.

Transit areas should be kept unobstructed to reduce the risk of falls.

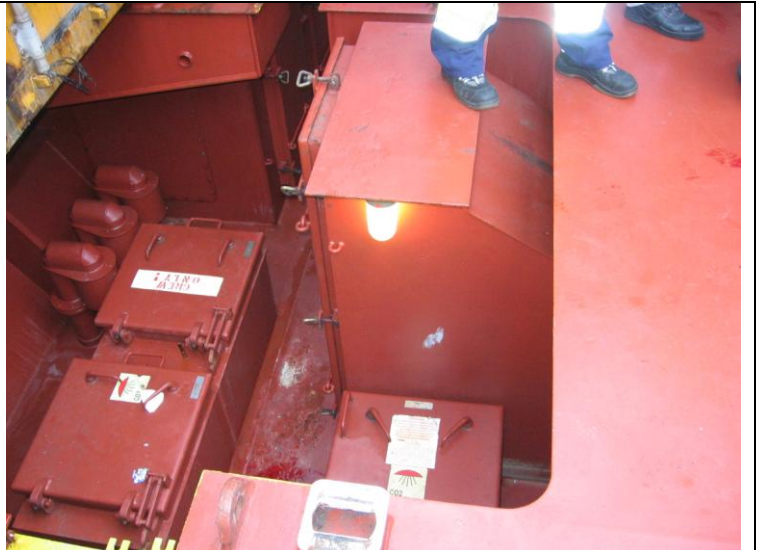
3. No firm and level working surface.

The space provided between the container stows for port workers to carry out such work should provide a firm and level working surface.
