Accident Investigation Ship Design Report 2008-01

Friday, 01st February 2008

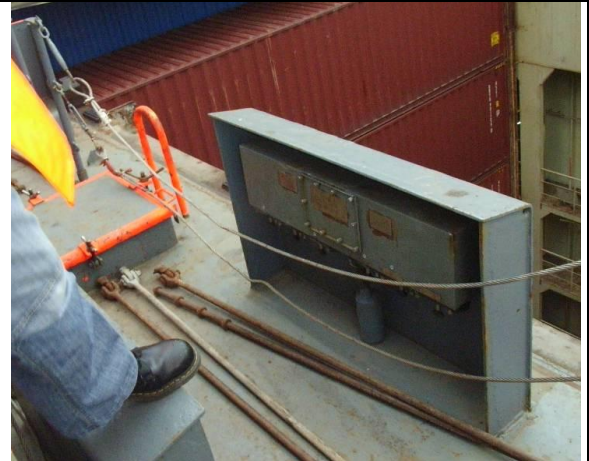
1. Too low fencing.

This fencing was just 0,4m high.

As a minimum, the top rail of fencing should be 1m high from the base.

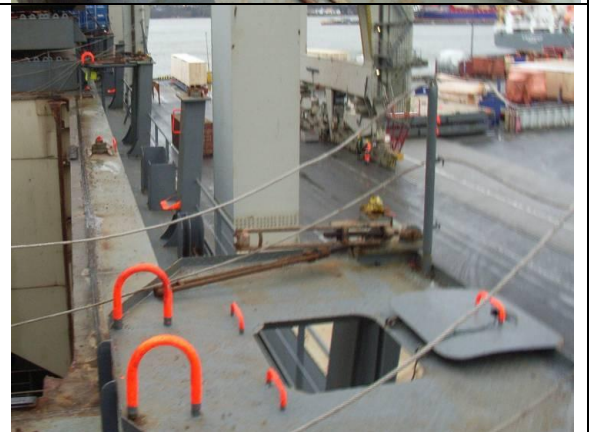
2. No adequate fencing.

Too low fencing and no sufficient device for tighten the fencing.
