# Accident Investigation Ship Design Report 2008-03

**Monday, 07<sup>th</sup> July 2008**

The spot check on board was leading to some weak points in construction and maintenance of the vessel.

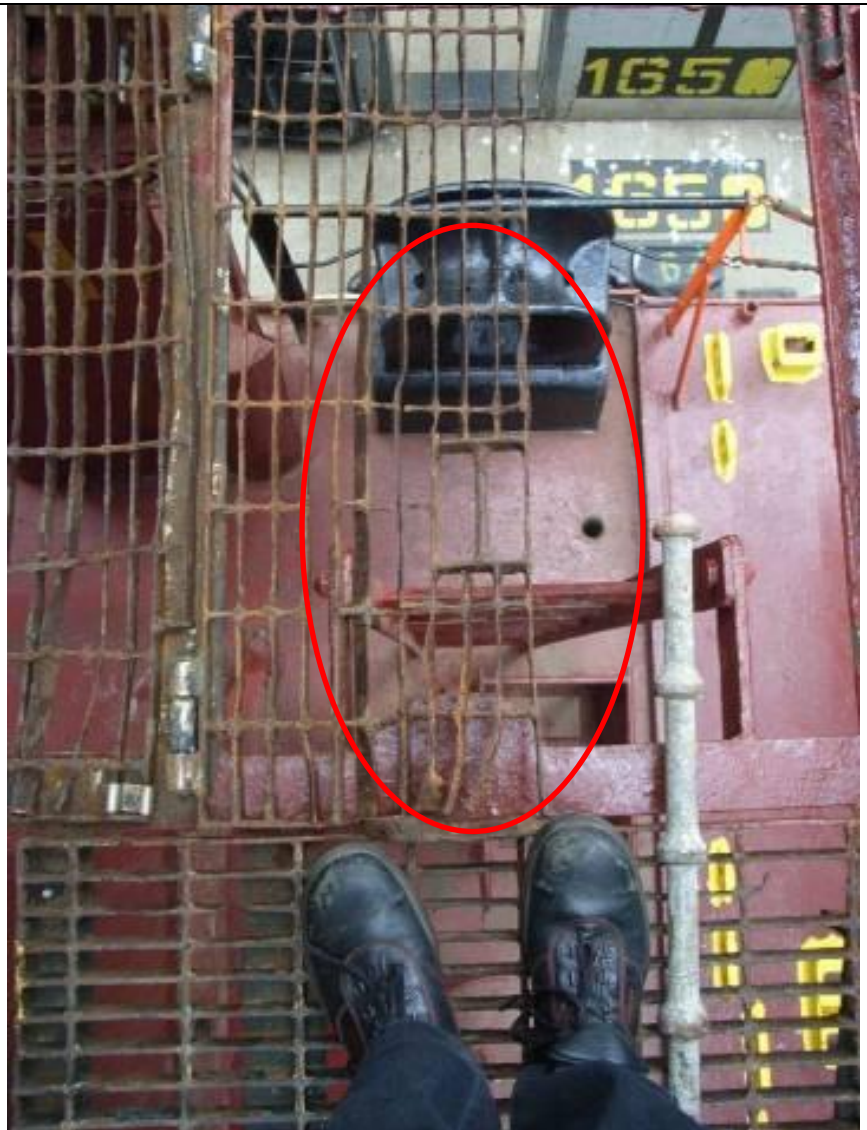
## 1. Rotten surface.

Risk assessments should be performed.  
Surfaces and flaps must be maintained.

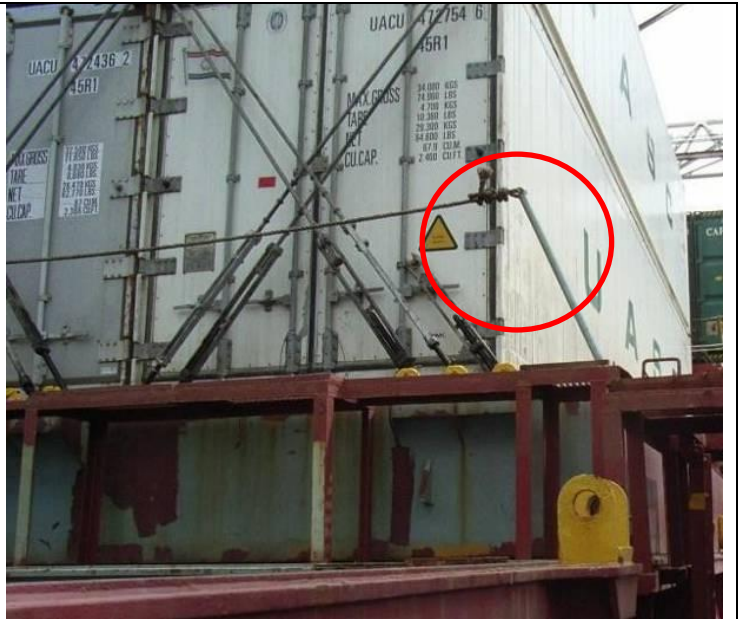
## 2. No adequate fencing.

As a minimum, the fencing should consist out of a top rail and one intermediate rail.

The strength of the fencing should be designed to prevent workers from falling.

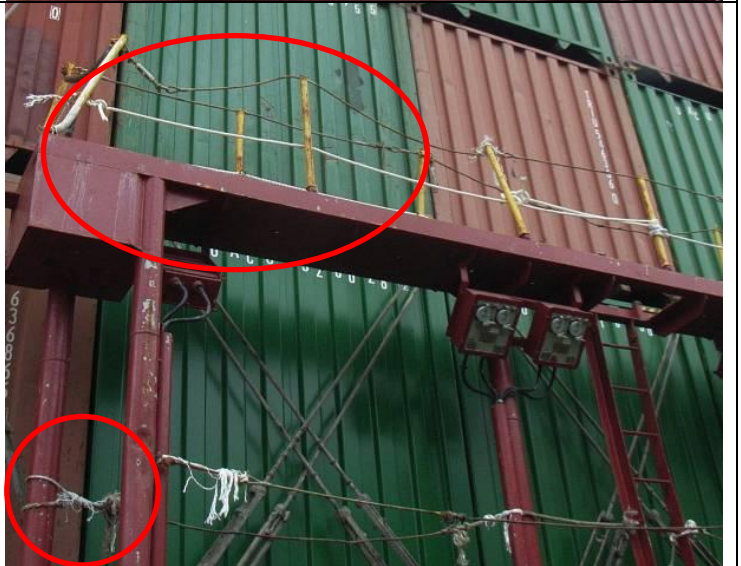
## 3. No adequate fencing.

Rotten fencing and no sufficient device for tighten the fencing. Both must be maintained.
