Accident Investigation Ship Design Report 2008-02

Thursday, 03rd July 2008

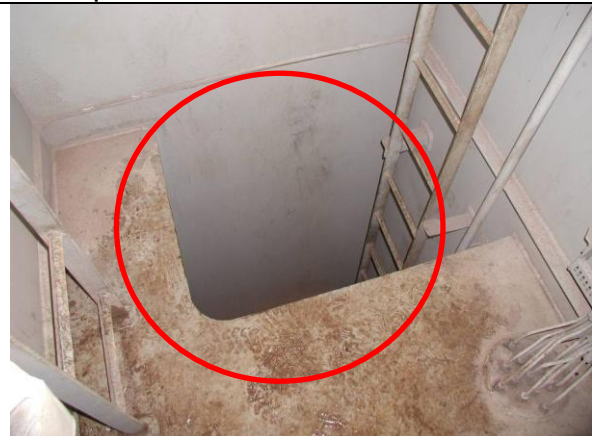
1. The unprotected opening in 2006.

Two years ago, a port worker was fallen into an unprotected opening. He received heavy injuries at his shoulder.

The Investigation on board was leading to a weak point in construction of the vessel.

Where a fixed ladder gives access to a platform through an opening in the platform, the opening shall be protected.

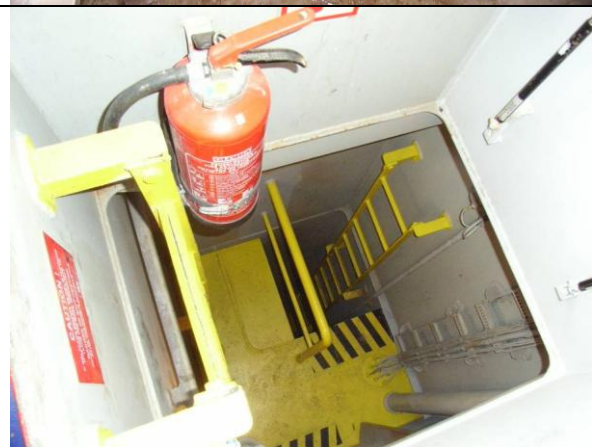
2. The safeguarded opening in 2008.

There are possibilities!

Risk assessments should be performed before an accident occurs.
